## Restoring Pre-Engineered Metal Buildings After a Fire

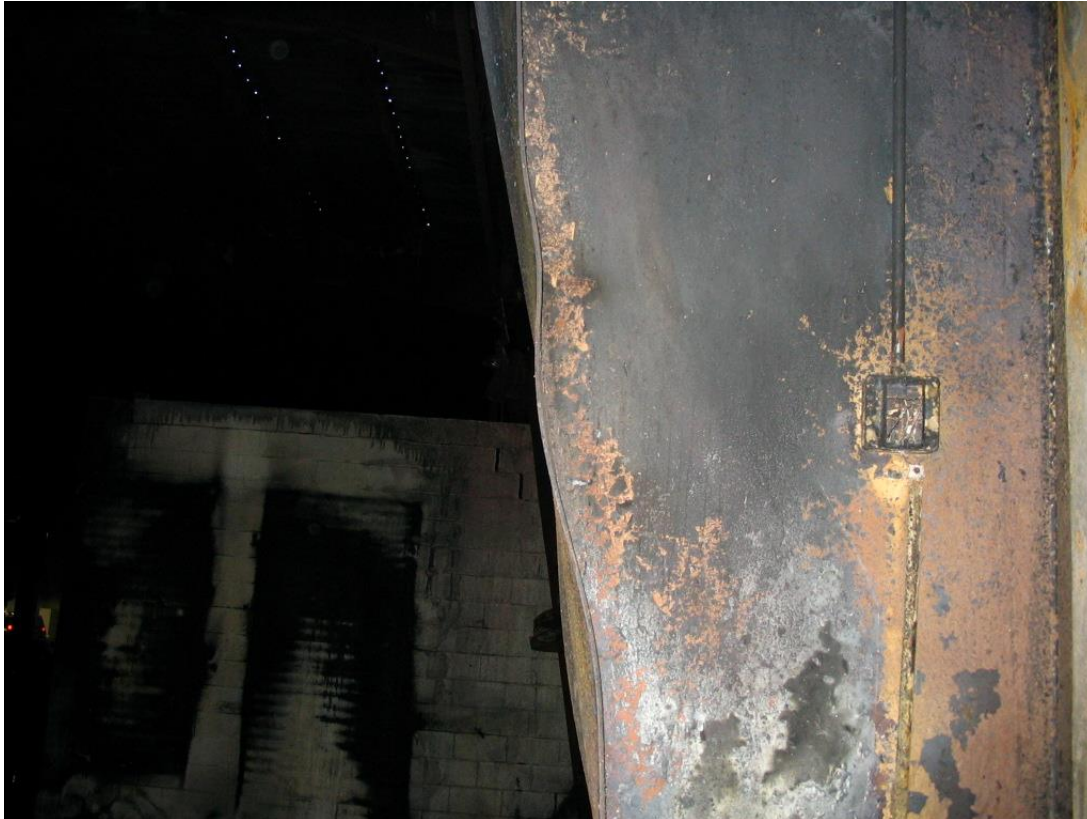
This “Frame” has obviously been heated to a point that the “Flange” has deformed, most of the time the deformation is not this obvious. The building did not fall so it is still holding the load. Sometimes a customer will wish to get back in business quickly and ask you to Clean, Seal, and Paint something like this. I would recommend, in writing, replacement of this component unless there is good reason not to remove it and the Engineer has developed an alternative to replacement.

In the background you can see light coming through the roof sheathing like little stars all in a row. This is where the neoprene washers used to seal the screws holding the R-panel down melted away allowing light to enter. Most of the time damage to the neoprene washers is not this obvious and the building needs to be inspected from the outside to determine if there is damage to the washers.
