GEOWEB[®]

STREAMBANK RESTORATION

BROOKTREE CREEK

Citrus Heights, California

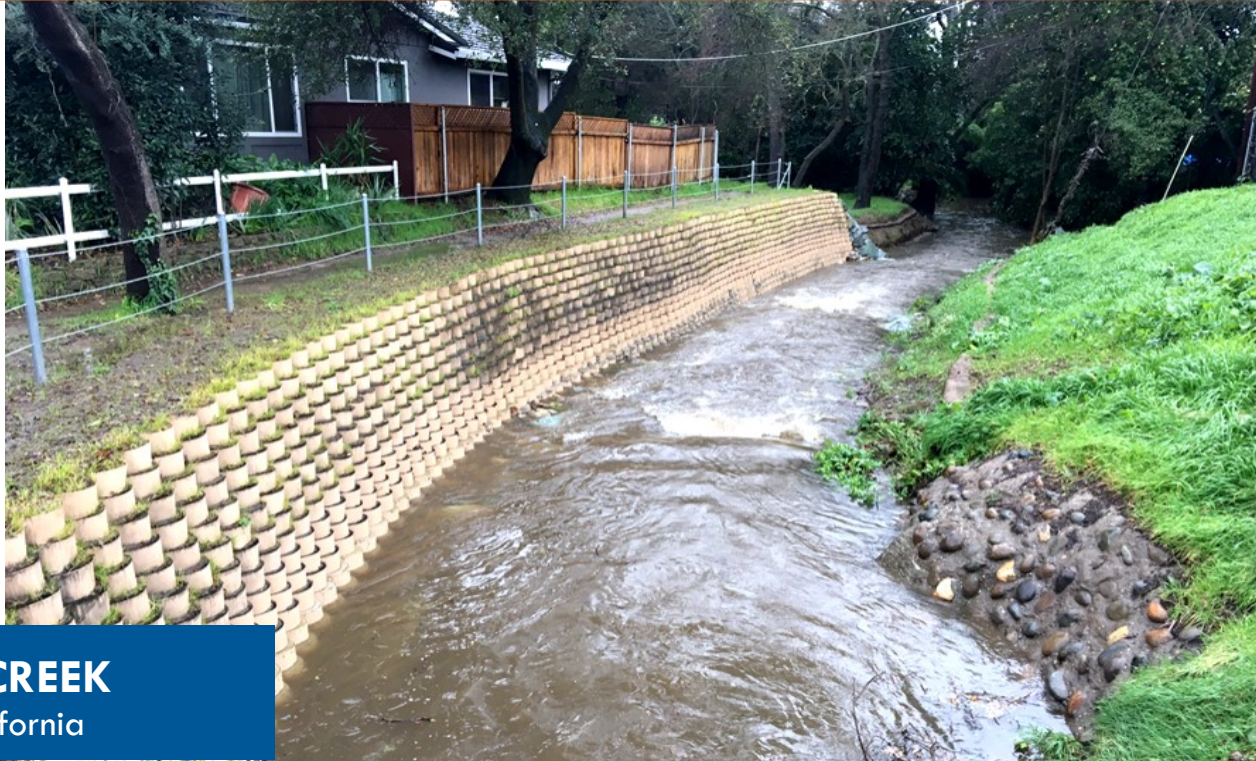
ERODED STREAMBANK REQUIRES REPAIR

Banks of a neighborhood creek that had eroded to the point where little embankment separated the creek from a homeowner's property required action. Large oak trees with roots that had become exposed also posed concern of falling into the creek or on property.

The Presto GEOWEB channel protection system was designed as a tiered structure to provide protection of the stream bank from further erosion. Large boulders set in concrete were also included in the design to better channel the runoff water by creating a series of over-flow pools to help prevent downstream erosion.

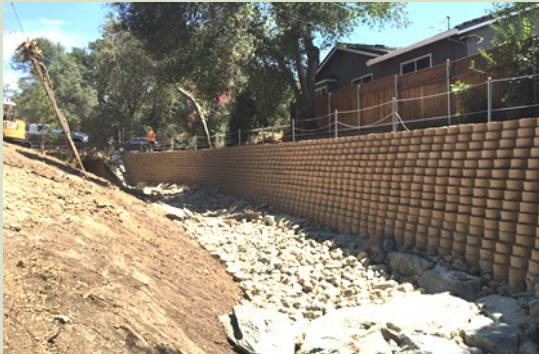
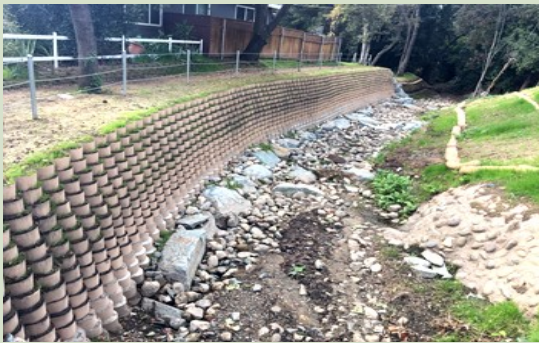
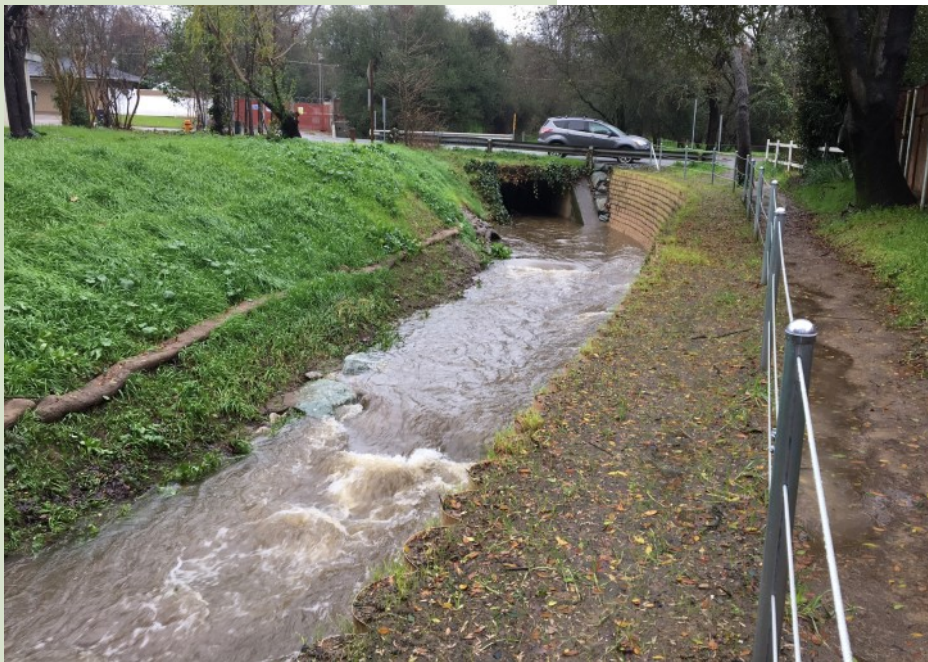
Once the project was designed, the construction started by removing the oak trees with exposed roots that could not be saved in the excavation of the new channel. Platipus percussion anchors were driven into the bank and tied off to a deadman anchoring pipe. Kevlar tendons were attached to the GEOWEB panels and tied off to the deadman anchor to secure the wall. Mirafi 3XT geogrid was installed every 4th lift to provide the support required for this installation. The GEOWEB footing courses were filled with concrete to provide a non-erodible base. Upper GEOWEB courses were filled with topsoil in the front exposed fascia cells to provide a growing media for vegetation, and then covered with Enkamat 7010 Turf Reinforcement Mat to prevent infill loss.
