The city of Richfield, OH, was experiencing pavement raveling less than one year after applying HMA. The cause of the premature raveling was believed due to reduced asphalt in the mixture. There was two options to resolve the problem: 1) remove and replace the HMA or 2) apply an effective surface treatment to stabilize the pavement matrix.

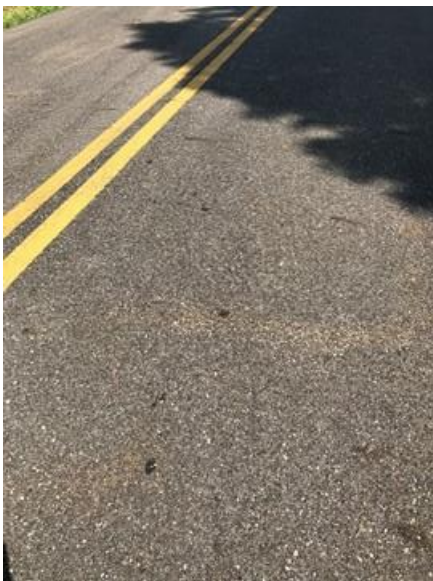
Shown is the surface before rejuvenator. After less than a year, the pavement is oxidized and starting to ravel.

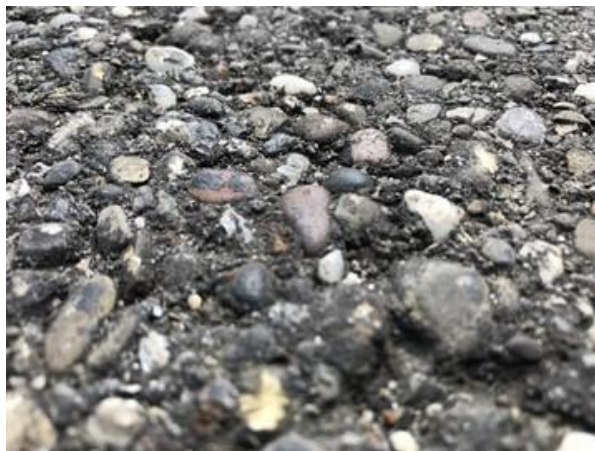
(Showing exposed aggregate before application)

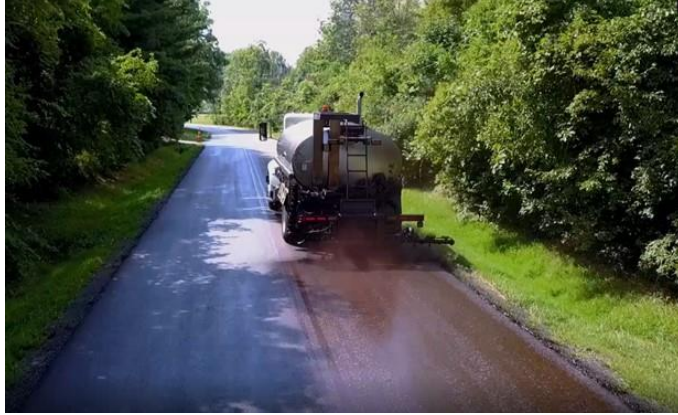
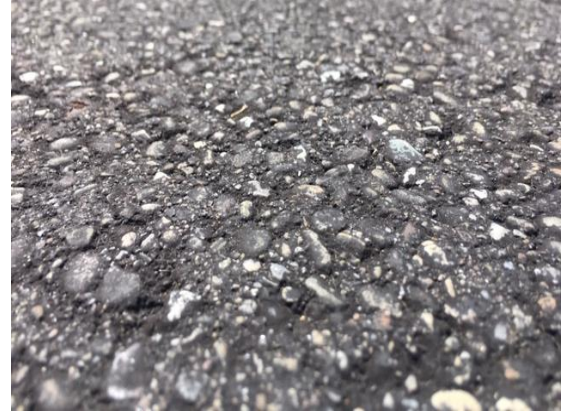
After application with an Etnyre Application Truck, the surface was fully coated with the aggregate less exposed. Typically HMA contains 6% wt asphalt; the rejuvenator added approximately 1% asphalt to the top quarter of an inch asphalt. In addition to penetrating and rejuvenating the in-place asphalt.

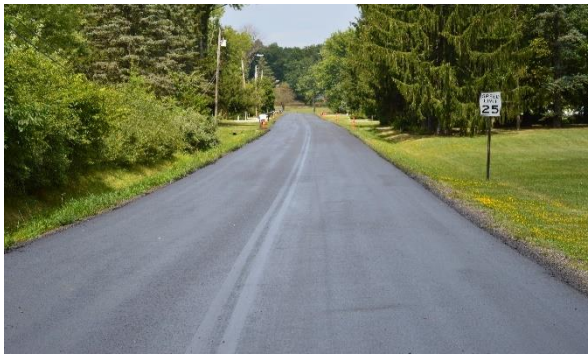
Rejuvenator covered all aggregate and pavement striping.

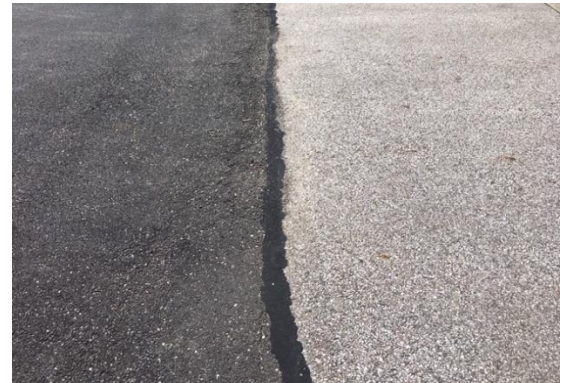
Starting spraying location, after one year.

One year after the rejuvenator application, the city of Richfield is pleased with the rejuvenator performance. Future maintenance projects are planned for the rejuvenator due to positive performance and cost savings relative to milling and overlaying.
