PROJECT SUMMARY

Application:
Curtain Grouting

Product Used:
AV-275 Soilgrout™

NOT YOUR AVERAGE GAS MAIN GROUTING PROJECT

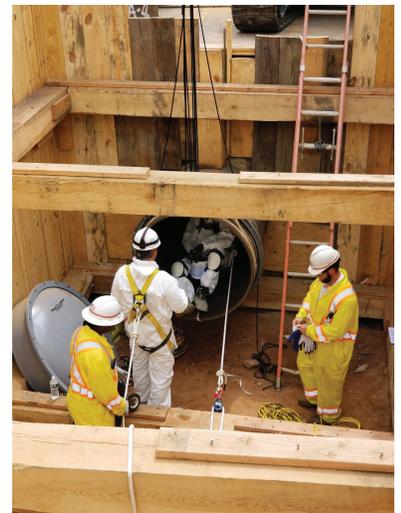
The 42" gas main pipe was angled at a 45° decline that would lead to a flat area, then another 60° angled decline to another flat area, where there was a 45° bend to yet another 45° decline. At the bottom of this last pipe drop, there was a steel elbow and short section of steel pipe that connected two cast iron pipes which was the source of the infiltration.

After mixing AV-275 with its AV-276 catalyst, Camden began pumping through drilled holes in the pipe with a Graco 495 pump into the soil. Scott Laubshire of Camden expected to use between 60-120 gallons of grout for this project. "As a grouter, you can generally estimate the amount of grout that will be needed based on project specifics, so we prepared to pump at least 60 gallons into the soil" says Laubshire. "You can imagine the look on my face when we pumped five gallons of AV-275 and the infiltration stopped – if I had not seen it happen, I would not have believed it. This was one of those odd-ball projects."
