# COATINGS CREW GETS MORTUARY FLOOR RIGHT

Demo, reslope, and waterproof the embalming and staging rooms at busy Southern California mortuary

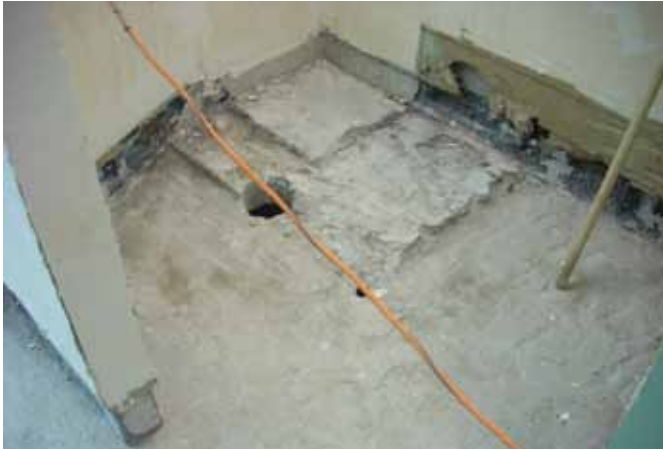
**ABOVE ▲** “When we demoed the existing tile deck we discovered a 5" (12.7cm) sand mortar aggregate. This was unusable for our specified coating application and the floor had to be resloped.”

After a discussion with the owners, the Raider crew used DeWalt jackhammers and hand tools to remove the sand aggregate, exposing the existing above-grade concrete slab.

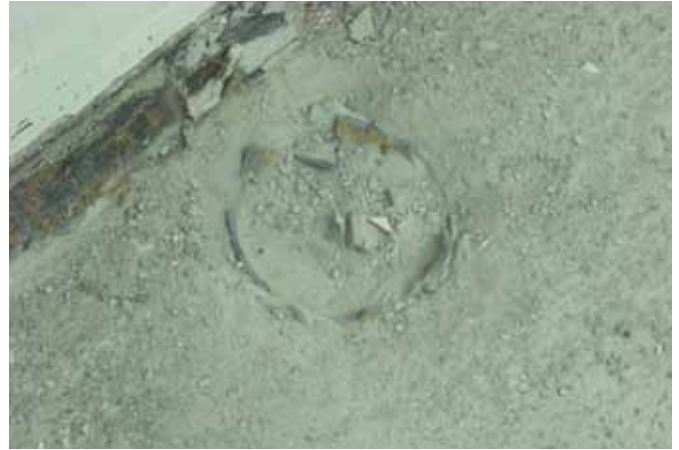
**ABOVE ▲** “As we exposed the slab we uncovered an old set of unused pipes that given — the age, setting, and possible use — had to be removed by the mortuary,” explains Tabrizi.

that the pipes were removed and that the room was cleaned and decontaminated. Then we returned.”

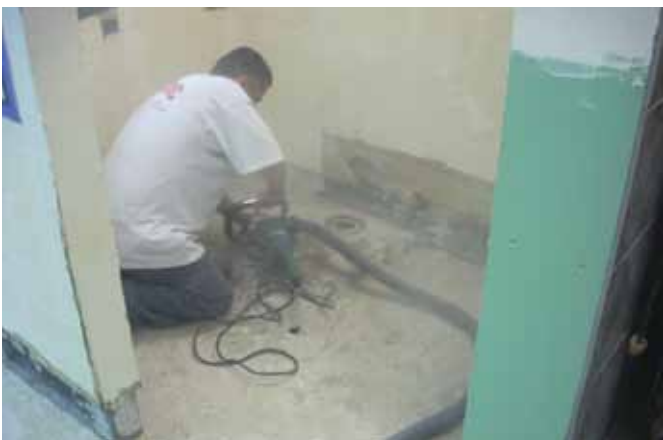
**ABOVE ▲** “The floor that we were working on was on the second floor of the mortuary — directly above a client area — so it had to be absolutely watertight,” says Tabrizi.

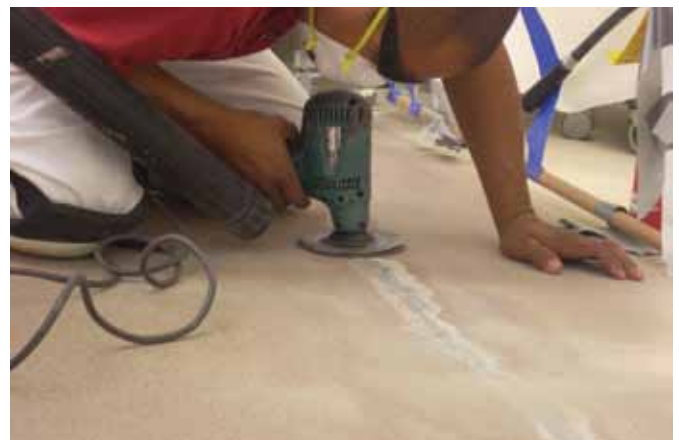
**ABOVE ▲** “We used hand grinders equipped with 12" (30.48cm) disks to reach into the corners,” says Tabrizi. “We created a heavy profile.”

Upon their return, the Raider crew used a Blastrac 1-10D machine to blast the entire slab in preparation for the installation of the Mapei epoxy flooring system. “We also used hand grinders equipped with 12" (30.48cm) disks to reach into the corners,” states Tabrizi. “We created a heavy profile. At this time we also installed new drains.”

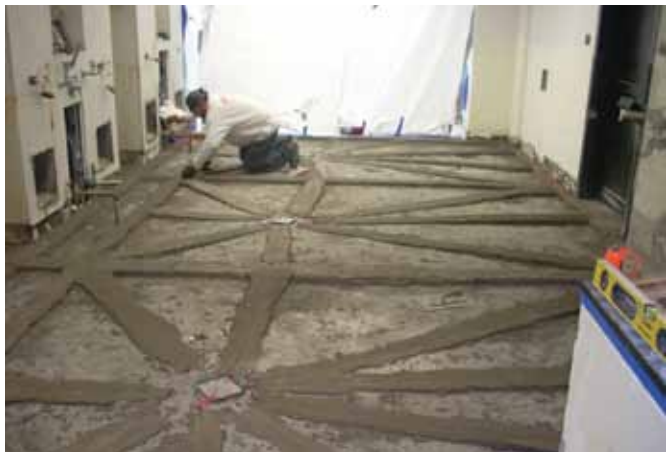
**ABOVE ▲** The crew used lasers and level strings and Mapei's Mapecem 202 — a polymer-modified, fast-set cementitious mortar — to build curbs for sloping. Any gaps between the slab and the drains were bridged with EPMAR's SS1202-2 epoxy filler.

“We built the curbs for sloping using lasers and level strings and Mapei’s Mapecem 202,” Tabrizi explains. Mapecem 202 is a two-component, shrinkage compensated, polymer-modified, fast-setting cementitious mortar with corrosion inhibitors. “Also at this time, any gaps between the slab and the drains were bridged with EPMAR Corporation’s SS1202-2 epoxy filler. We

poured the epoxy into the gaps around the drains and taped it off to make sure that it wouldn’t leak out of the bottom.”

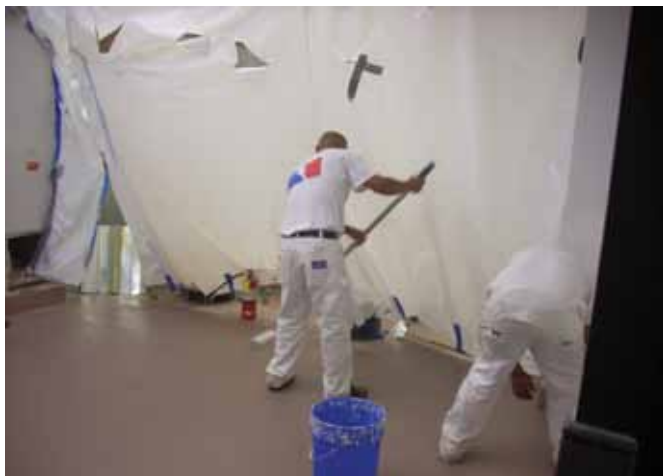
**ABOVE ▲** "During this entire project," Tabrizi explains, "Our work area was sealed off from the rest of the mortuary with plastic sheeting." The coatings crew was protected from any fumes, and equally as important, the mortuary could continue to operate as normal.

The crew reblasted the floor using the Blastrac machine, which also vacuums the dust as it blasts. "During this entire project," Tabrizi explains, "our work area was sealed off from the rest of the mortuary with plastic sheeting." The coatings crew was protected from any fumes, and equally as important, the mortuary could continue to operate as normal without having to worry about dust from the job site wafting into their work environment.

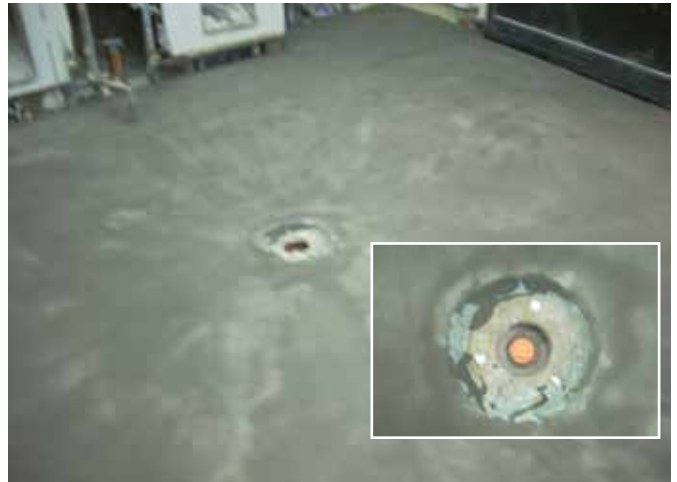
**ABOVE ▲** Tabrizi and his crew poured and rolled Mapecem 202 to fill in over and between the curbs creating "one solid, equal, level floor that sloped to the drain. At some places, the leveler was 3" (7.62cm) thick."

Curbs and drains in place, it was time to level things off. The Raider crew poured and rolled Mapecem 202 to fill in over and between the curbs creating “one solid, equal, level floor that sloped to the drain. At some places, the leveler was 3" (7.62cm) thick,” Tabrizi describes. According to Website data, Mapecem 202 is specifically intended for use in areas where fast drying is required to allow traffic within three to four hours. And Mapecem 202 achieves a full compressive strength of 6,700 psi (46,2 MPa) in 28 days.

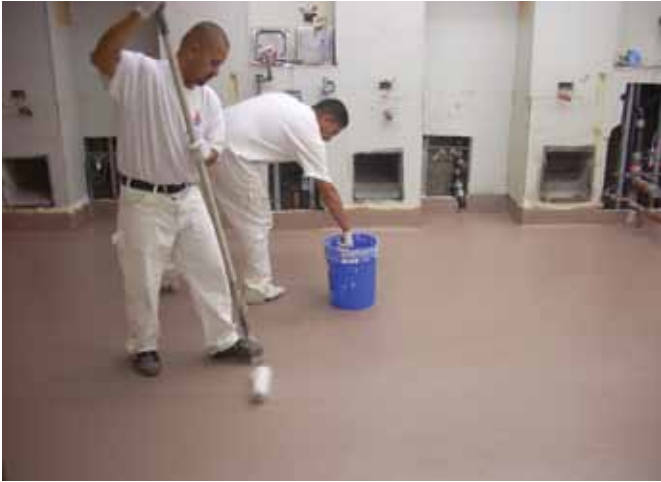
**ABOVE ▲** The crew roller-applied 20 mil (0.51 mm) DFT coat of Pacific Polymers' Elastomeric 6001, on top of the 3 to 4 mil (0.076mm-0.102mm) DFT primer and the Mapei system. But they had only just started.

At first, the coating process went perfectly according to plan. Using 9" (22.86cm), short-nap rollers, Tabrizi and his crew applied a 3 to 4 mil (0.076mm-0.102mm) DFT coat of Elasto Poxy, a solvent-based epoxy base primer from Pacific Polymers. This was followed by a roller-applied 20 mil (0.51mm) DFT coat of Pacific Polymers' Elastomeric 6001, a single-component, moisture-cured polyurethane. That's a thick 24 mils (0.61mm), give or take, on top of the already thick Mapei system. But the Raider crew had only just started.

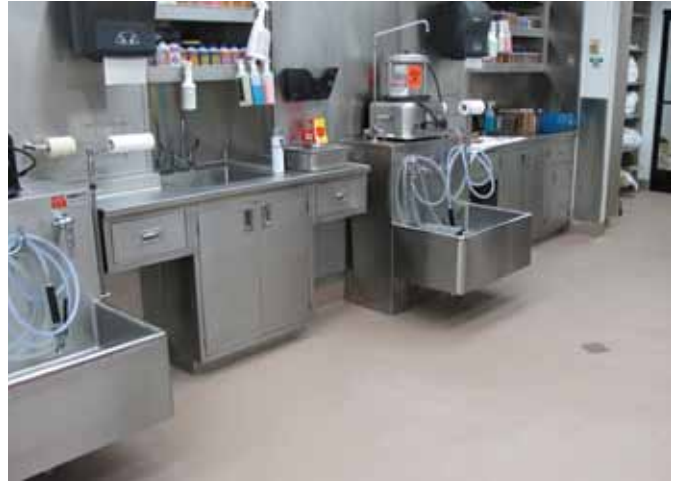
**ABOVE ▲** The Raider crew roller-applied the formaldehyde-resistant Wearcoat 100 top coat at a DFT of 4 mils (0.102mm) per coat. "And we put on two coats. We aren't taking any chances," says Tabrizi.

Problem-solving topcoat identified, the Raider crew roller-applied the Wearcoat 100 at a DFT of 4 mils (0.102mm) per coat. "And we put on two coats. We aren't taking any chances," says Tabrizi. "We joked that this floor is so thick that there is no room to walk in there. It's practically up to your ears."
