Noland Warehouse

Case Study

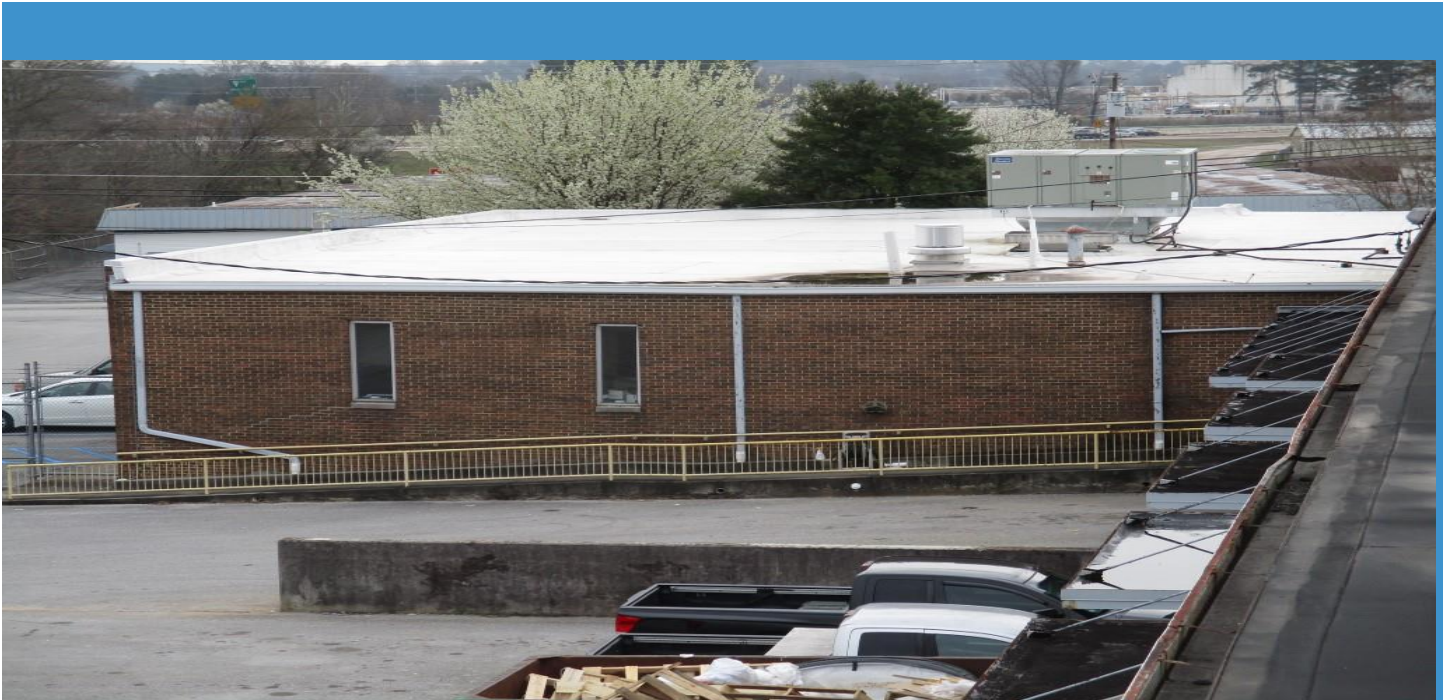
Deep Excavation

One challenge was to access the footings of the structure. In the discovery process we found the footings were deep and we needed a temporary shoring system to access the footings for stabilization.

Helical Piers

45 helical piers with retro brackets were used to underpin the foundations and attempt to lift the structure back into place. The helical capacities varied from 20K to 45K ultimate pounds.

Compaction Grouting

Compaction Grouting was performed to fill voids and stabilize soils deep in the ground. Bedrock varied in depth from 85 to 105 feet below grade.

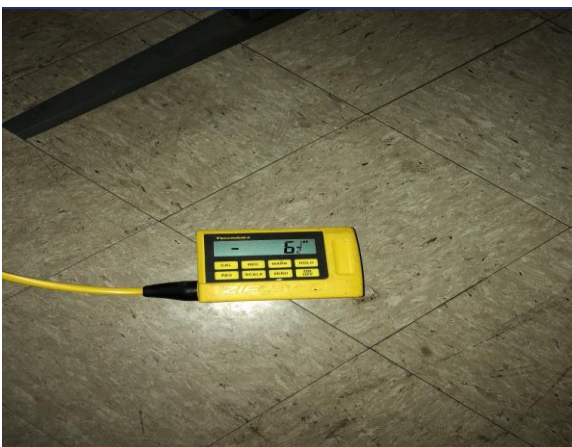
50-YEAR-OLD structure

Noland warehouse is a plumbing supply warehouse in Chattanooga Tennessee. The building was built in 1969 and over the last 10-20 years has been experiencing settlement in the office and warehouse spaces. Amount of settlement is about 6 inches as measured.

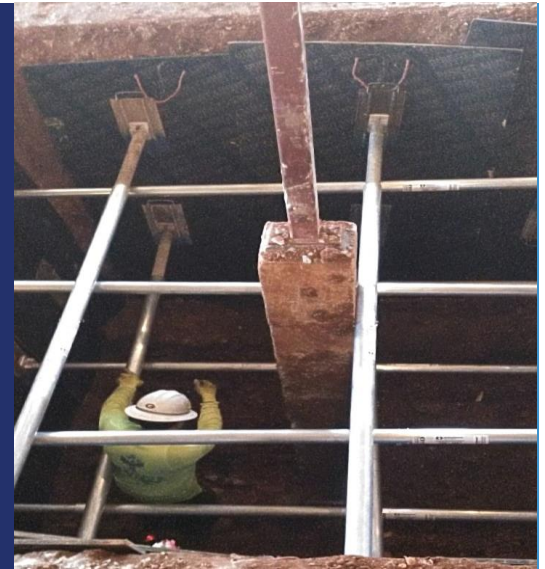
Deep Excavation

A speed shore system was installed in order to access the footings

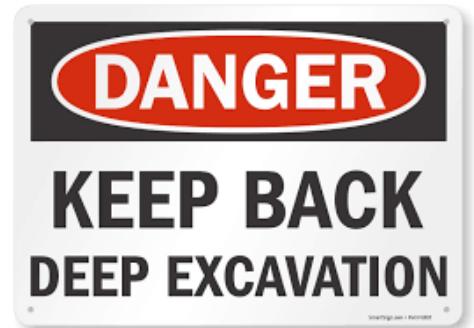
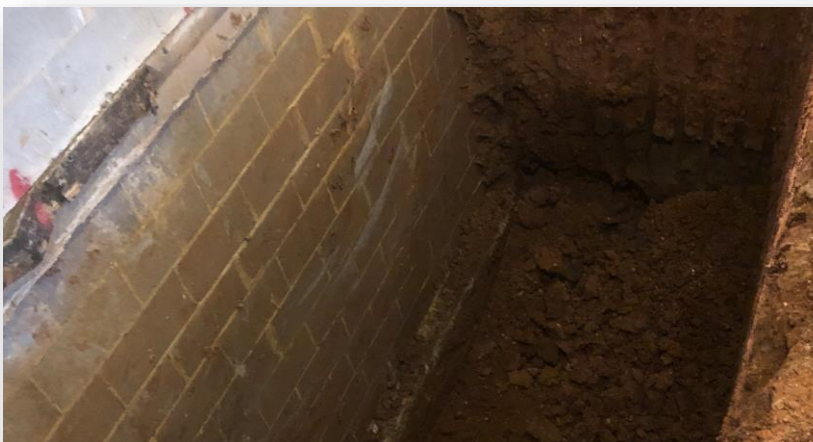
Access

Access to the bottom of the footings was required to install the helical pier. The helical pier retro bracket is a mechanical attachment to the footing. The bottom of the footing was 12 feet below grade. This speed shore system is installed without ever entering the excavation. Once it is secured it can be entered safely, which is important on every job where excavations are deeper than 4 ft.

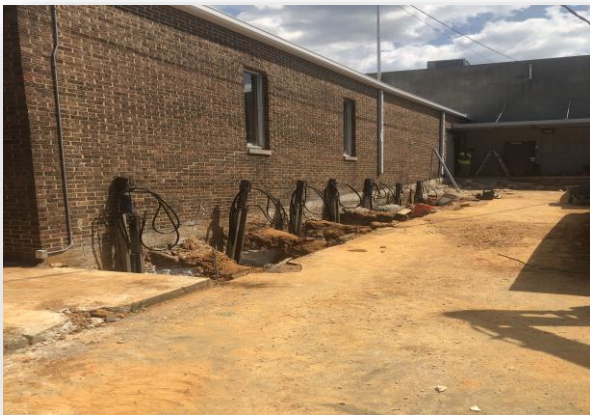
Helical installation

Ideal Helical Piers

A total of 45 2-7/8" x 12" inch diameter helical piers were installed to 20-40 ft in depth. Each pier was loaded greater than the safety factor of 2.

When lifting a structure of this much size and load, we decided it best to convert to our heavy-duty lifting ram assemblies. This system is fully hydraulic with 80K pounds of lifting capacity out of each ram. Once the assembly is mounted the structure is lifted with the push of a button.

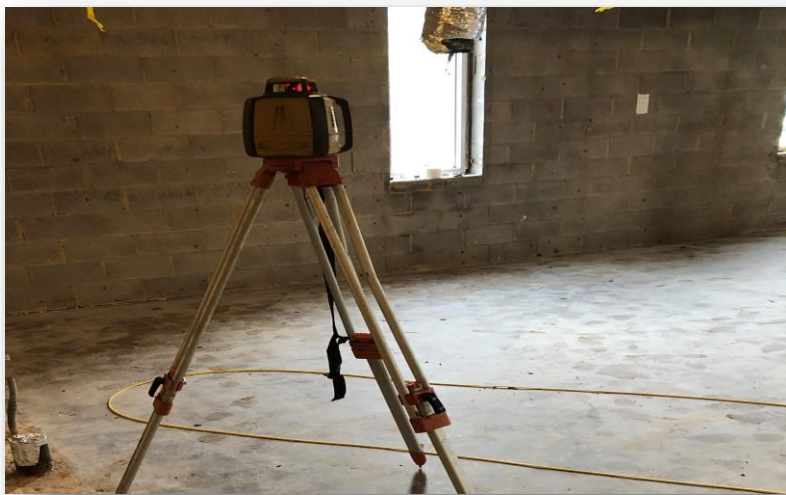
During the lifting process a series of lasers and monitoring devices are being used to watch the lifting process. During lifting there are times that adverse reactions occur to prevent lifting successfully like rotation of the wall which is why we stopped at only 2 inches of lift. Ultimately the foundation is stable and cosmetic repairs will be made to the structure.

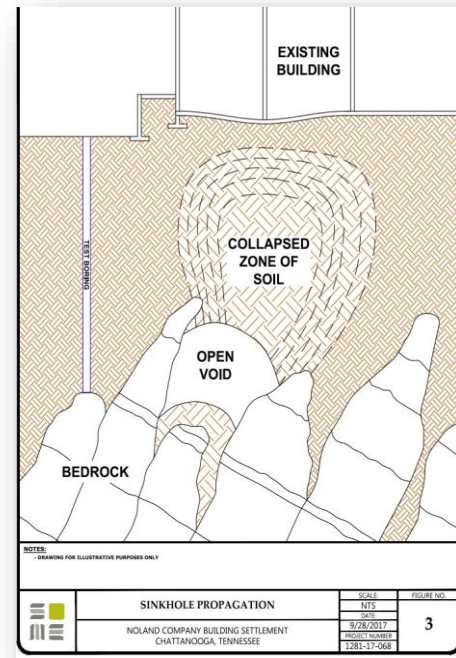
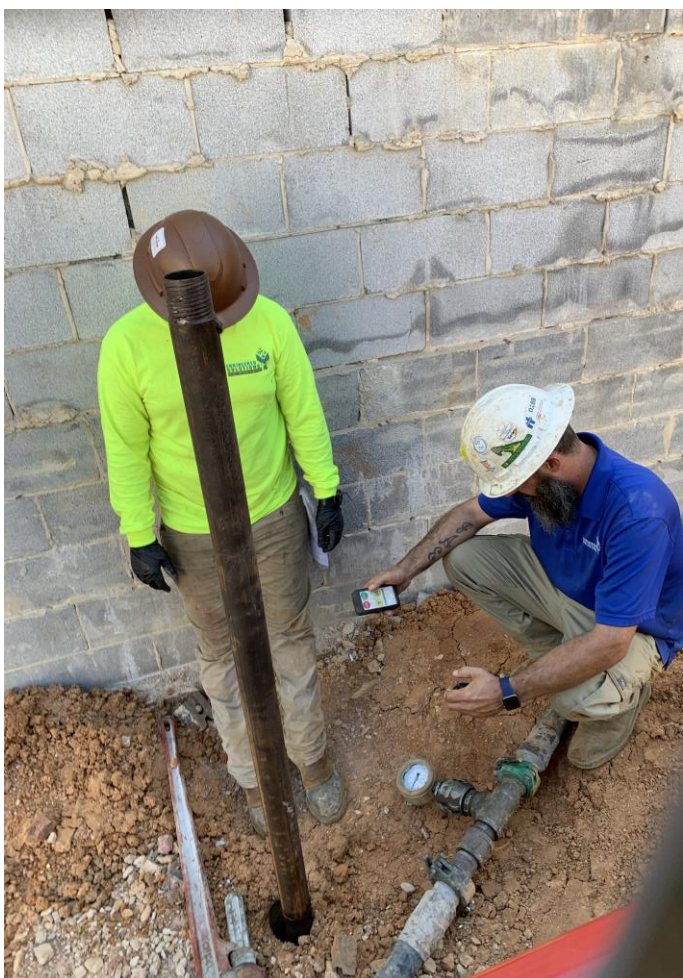
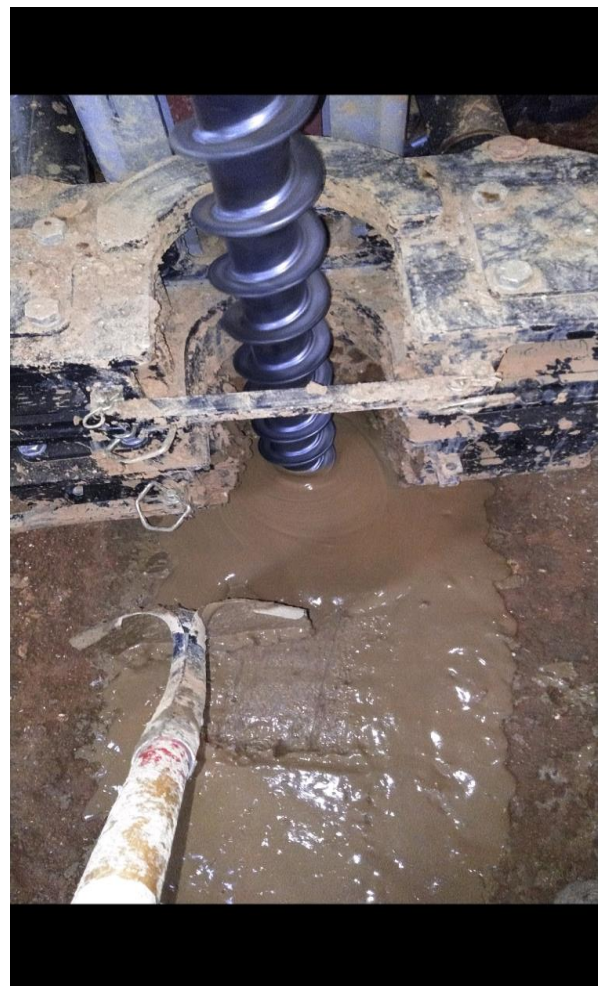
Bedrock Depths

We were tasked with drilling inside the building in a low headroom scenario, so we used our electric powered rotary track drill to auger and case the grout injections to bedrock. Bedrock varied from 85' to 105' ft. The Zone of influence began at 65' to 70' ft down to bedrock. This zone of influence consisted of a very soft and wet clay or "muck". The capping process limited us to only inject 5 yds on top of bedrock and let set for 24 hrs. in hopes of "capping" the top of bedrock. This would create a seal for us to build up on. The compaction grouting process took about 45 days with 21 total injections inside and outside. The final grout quantities injected to remediate the sinkhole was 635 cu yds. All injections were re-drilled in order to verify they were completely full no other voids were present.
