# Aiming for the Stars

## Observatory Renovated by Concrete Cutting

**A CSDA member recently cut and removed approximately 100,000 pounds of concrete as part of a two-phase, \$5.2-million renovation project at a planetarium in Chicago. The work involved creating several 9.5-foot-tall openings, some as wide as 6 feet, in the 14-inch-thick exterior wall of an observatory with a raked concrete finish. Further precise cutting and removal tasks inside the cylindrical-shaped building were required to help transform it into a modern tourist attraction.**

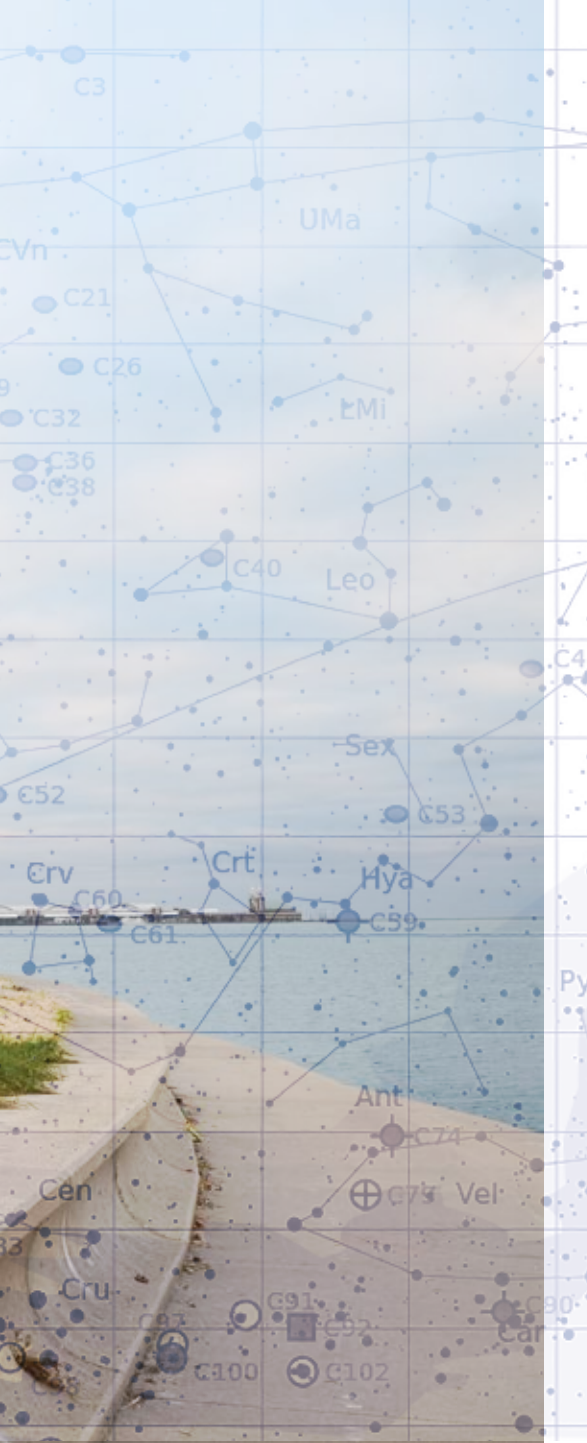
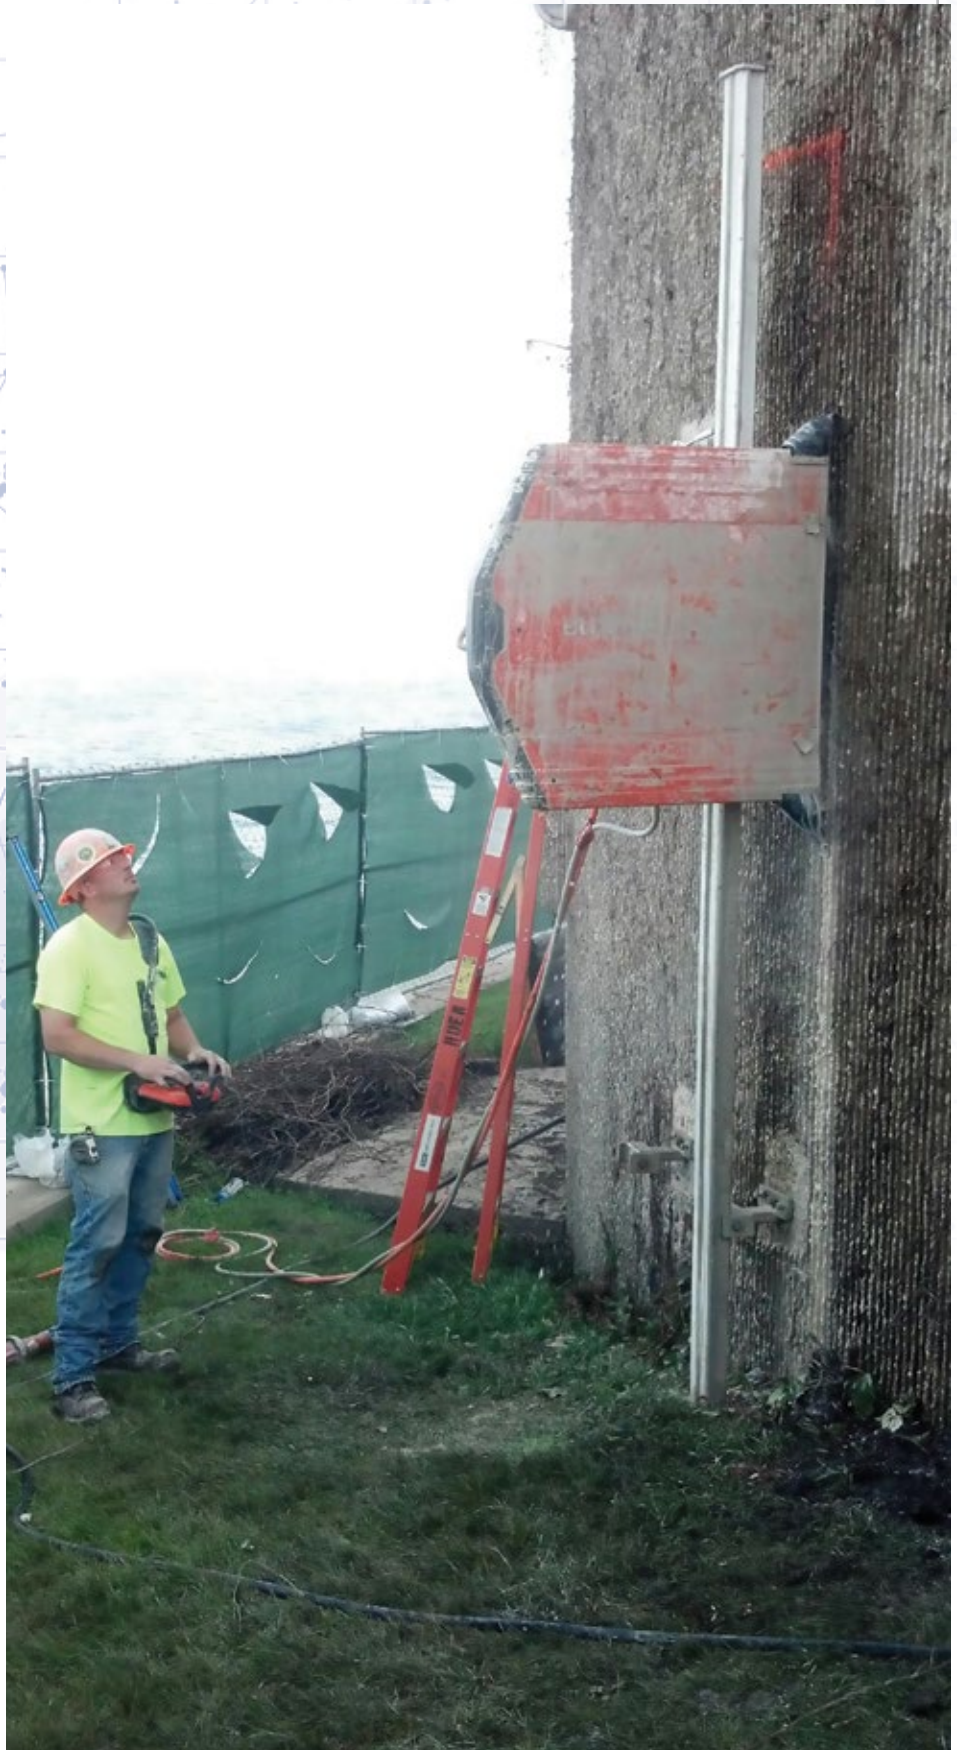
A \$1-million project was planned to renovate the Doane Observatory.

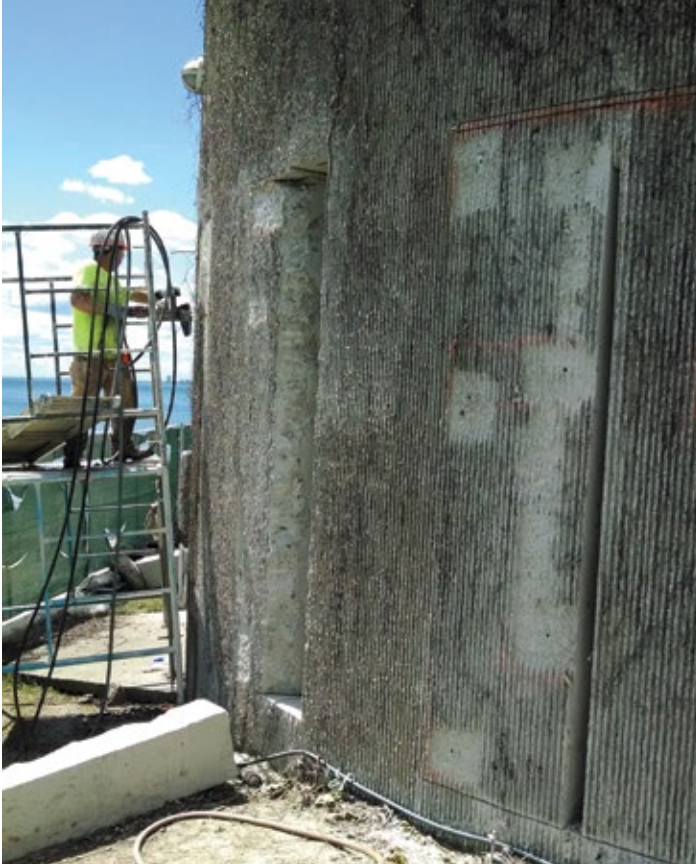
The contractor created six openings 9.5 feet tall in the exterior wall.

It was the job of a specialist contractor to cut four window and two door openings in the 14-inch-thick concrete wall of the observatory. Window openings measured 9.5 feet tall and 3 feet wide, while the door openings were the same height but 6 feet wide. Beyond the exterior wall was an 8-inch-thick interior concrete wall that formed a hollow 12-foot-tall, 12-foot-diameter space in the center of the building. Half the circumference of this internal wall was to be completely cut and removed as part of the building's renovation, allowing the space in the center of the

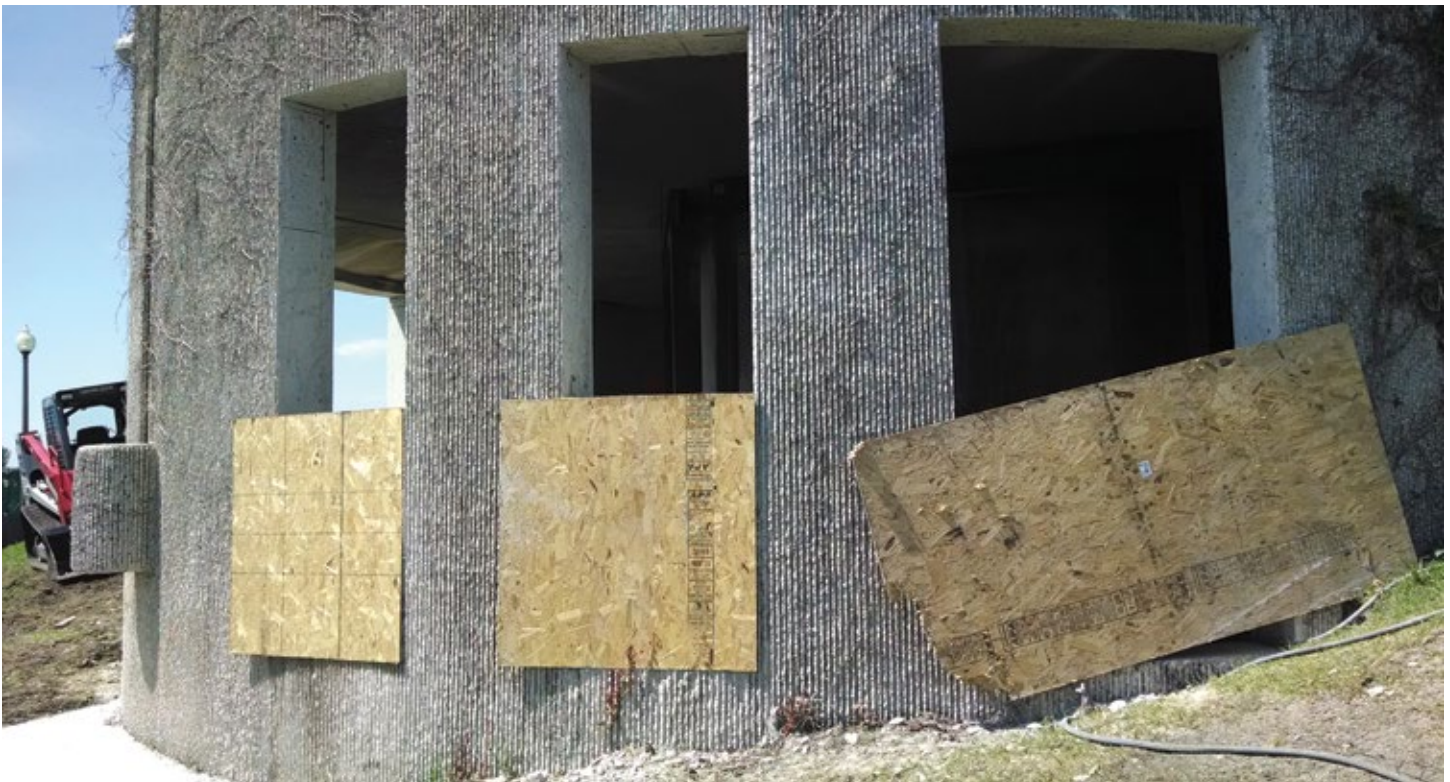
A wall saw was used to cut through the 14-inch-thick concrete.

to mount a Husqvarna 482 HF wall saw fitted with a 32-inch-diameter blade. Angles were calculated and marked out so that the contractor achieved a square opening in the curved wall of the cylindrical structure, then slurry control and containment was set up to protect pedestrians using the nearby Seawalk pathway. Troop Contracting installed a temporary fence with sandbags placed around the base to contain runoff.

A cutting technician set up equipment at the first cutting location and made two 9.5-foot parallel vertical cuts at the specified width. The track-mounted saw was then positioned horizontally at the top, then bottom of the vertical cuts to create a rectangular cut section in the wall. The concrete section was removed from the wall before the team from Cobra moved on to the next location. This process was repeated until all six openings were made and the exterior work completed. A gas-powered chain saw from ICS and a K6500 ring saw from Husqvarna were used for some of the corner cuts.

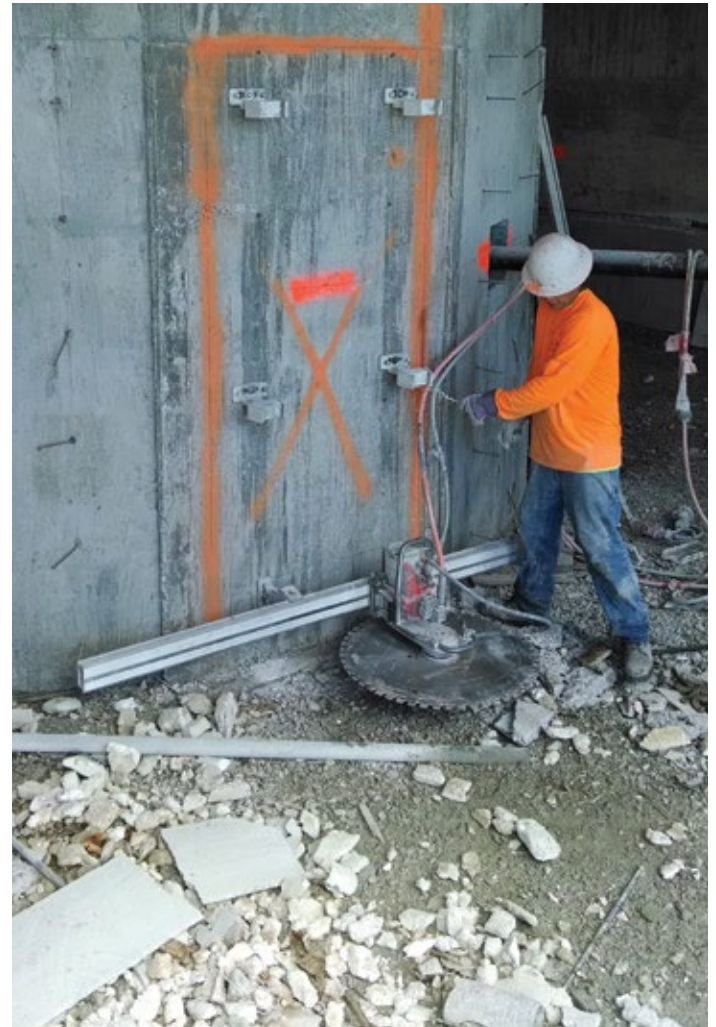
Half the circumference of the interior wall was cut and removed.

Having created a series of window and door openings in the exterior wall, the contractor now had easier access to the interior wall of the observatory and more options for the removal of cut sections. Cobra had to calculate the measurements of the wall and plan to cut exactly half the circumference, making sure end cuts were at a 30-degree angle. Top cuts had to be flush with the ceiling, but cutting technicians found that the structure had steel erected on the outside. This was a problem, because

the plan was to remove cut sections towards the steel. So Cobra had to work in reverse order—sawing and removing the bottom 10 feet first, then sawing and removing the top 2 feet to avoid damaging the steel and the wall that was to remain.

Cutting technicians cut the 20-foot length of 12-foot-tall, 8-inch-thick wall using the wall saw, taking three days to complete. All cut sections were safely removed from the work area using straps and a skid steer before being hauled from site.

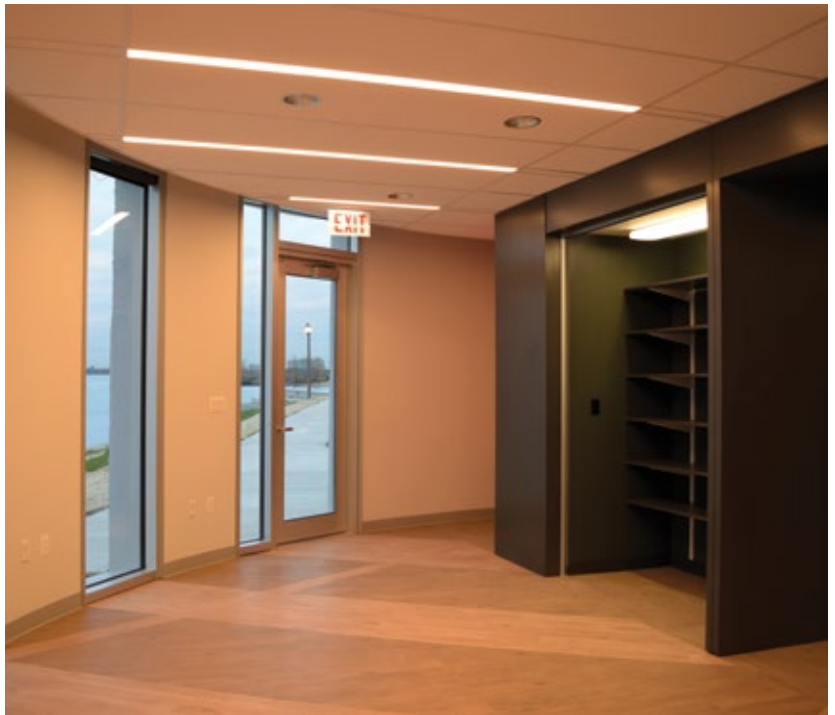
Approximately 100,000 pounds of concrete were removed from the site.

All sawing work was completed in a little over three weeks and produced around 100,000 pounds of cut concrete sections. All pieces were hauled from site by the contractor's Ford F650 Dumpbody. The project was completed on time and within the agreed budget between Cobra and the general contractor.
