Public Works
Project of the Year
Awards Program

Falls Road Culvert Replacement
Disaster or Emergency Construction/Repair
Less than \$5 Million

Prepared by
Clark County, Washington
Public Works - Engineering &
Construction Division

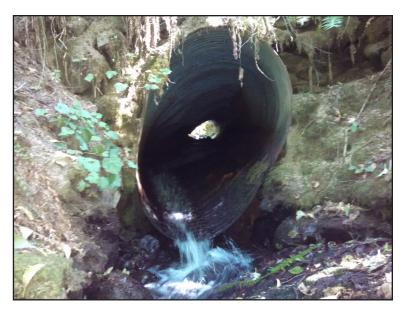
The crew chief, during his visit in early September, observed that the culvert's deterioration had accelerated, to the point the metal was partially crushed and in danger of collapsing completely.

The collapsing culvert under Falls Road, one month before it was replaced in early October 2014.

Faced with the likelihood that a minor concern could become a huge problem for these households, Clark County Public Works responded swiftly and nimbly in coordinating an emergency plan to remove the partially collapsed culvert and install a new 60-inch culvert with less than a month's lead time.

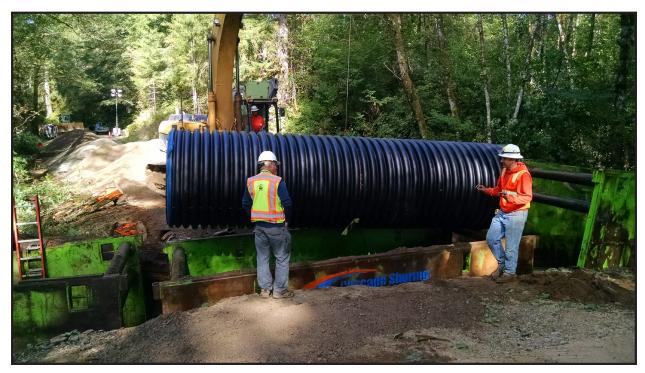
A new 60-inch culvert is gently lowered into place.

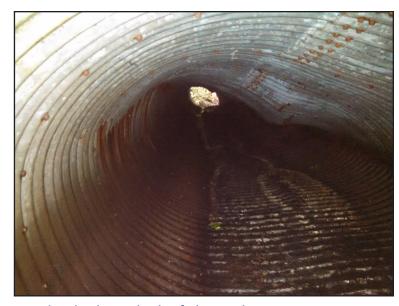
Another look inside the failing culvert.

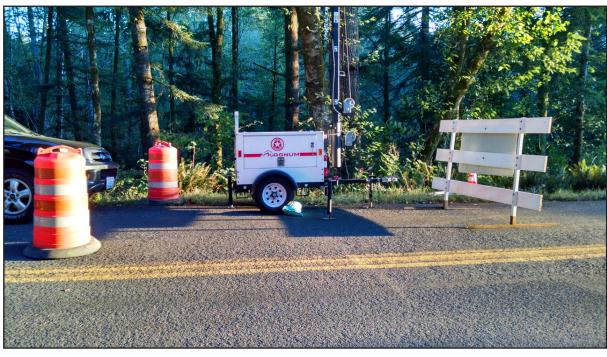
Traffic control and closure barricades were part of the emergency replacement project.

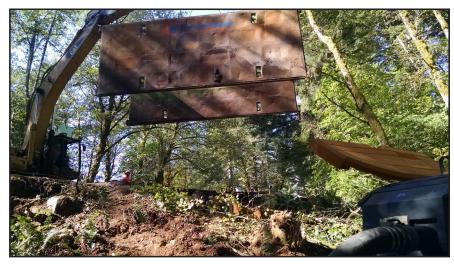
Metal plates were used to shore up a trench for the replacement culvert.

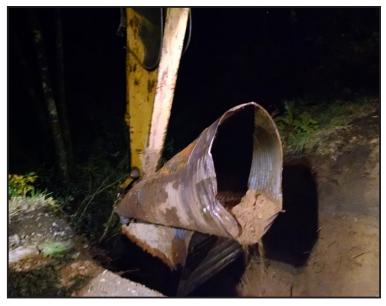
The old culvert that was removed after sunset Friday.

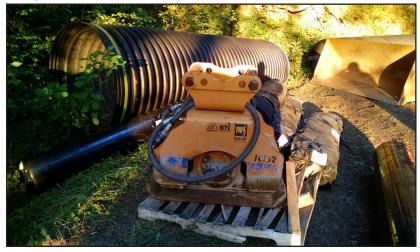
The contractor mobilized equipment even before the road was closed.

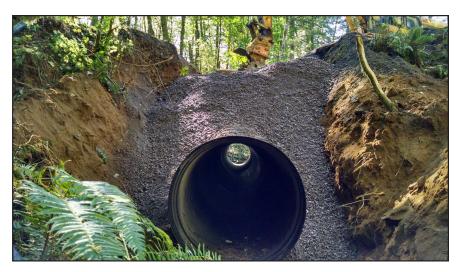
The replacement culvert, shortly after it was put into place.

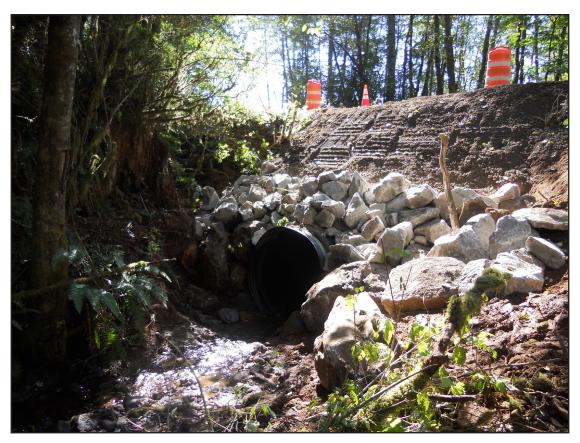
Water runs into the replaced culvert on the upsteam side.

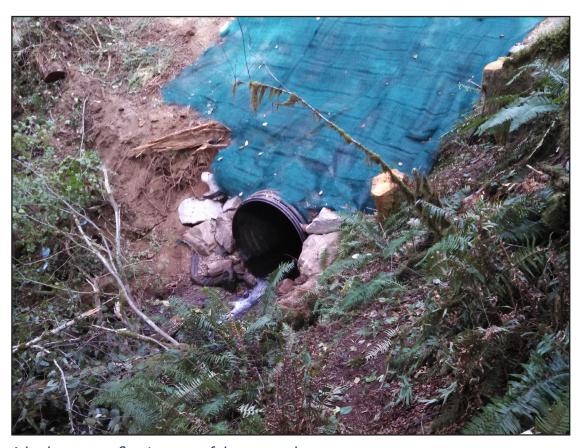
A look at water flowing out of the new culvert.
