Replacing Failing Brick Façade

The inside story to a complete renovation of a Minnesota Hampton Inn outfitted with ReVyvit.

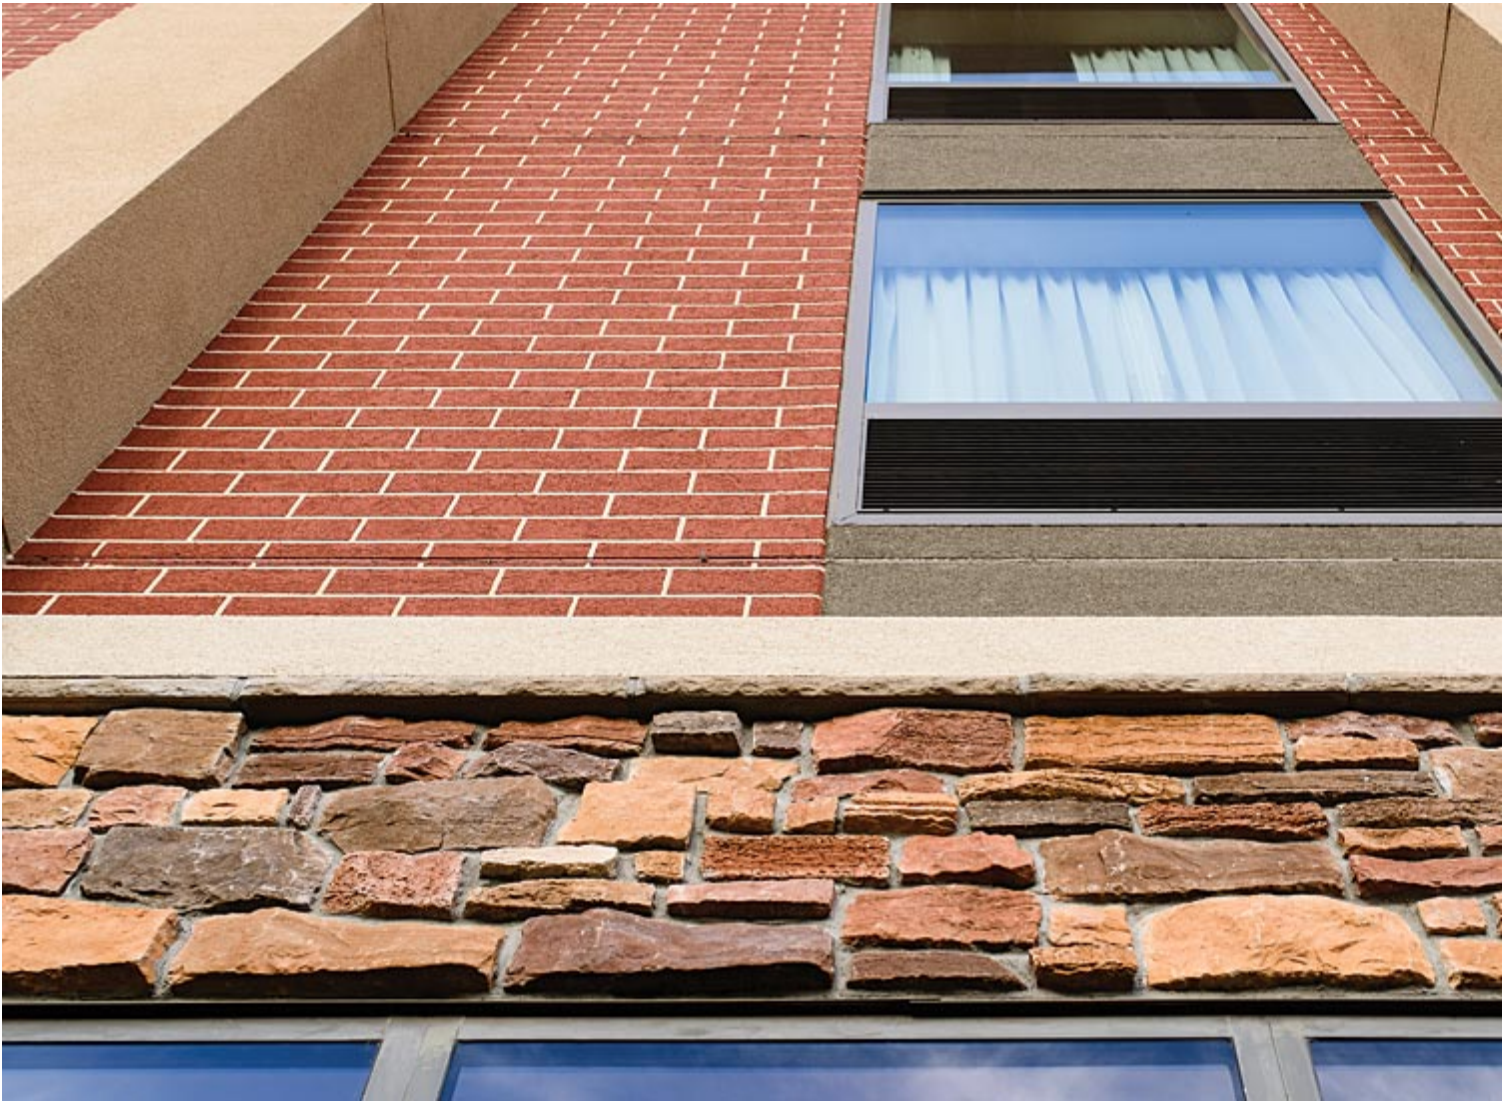
A close up of post renovation exterior with new windows and mix of cladding materials.

Needing an attractive weather-tight solution, the owner TPI turned to Dryvit, which employed its ReVyvit by Dryvit renovation solution, to renovate the building exterior completely. The renovation required stripping off the original cladding to the studs, and installing an Outsulation system to create a continuous insulation solution that resulted in a better performing, more attractive building.
